Investigation of Fiber-Reinforced Polymer for Seismic Rehabilitation of Concrete Structural Frames With Unreinforced Masonry Infill

Ghassan K. Al-Chaar, Justin B. Berman,
and Steven C. Sweeney

May 2003

ERDC/CERL TR-03-10

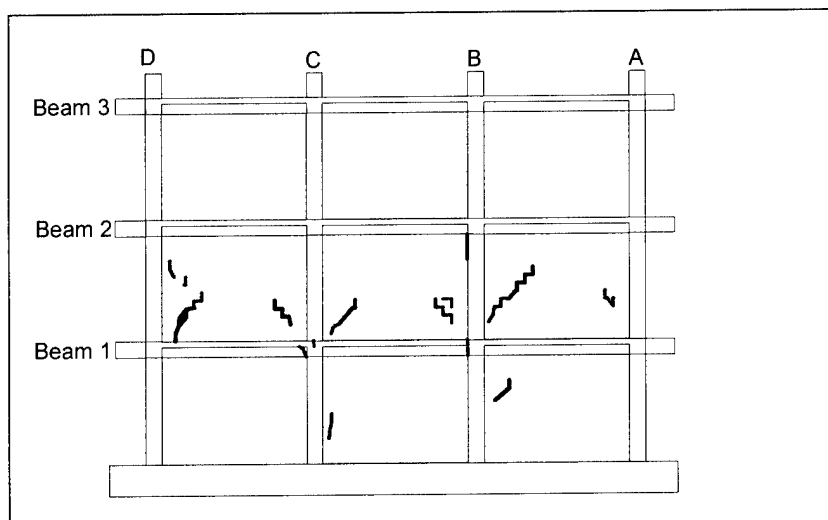
Figure 5.3. Cracks appearing during cycles 25 through 28.

As the test progressed from cycle 25 – 28, the cracking pattern remained mostly in the same panels and quadrants as the earlier cycles. Again the majority of cracks were stair steps, either continuations of existing cracks or new ones. They were typically found in the bottom half of the panels moving upward toward the center, visually indicating strut action of the CMUs. Figure 5.3 shows how the cracks had propagated toward the toe of the second-floor panels during the negative stroke. These cracks would not propagate any further during the test. During these cycles, the first slab and beam cracks formed at the middle two joints along the second floor, where the stress concentrations were highest.

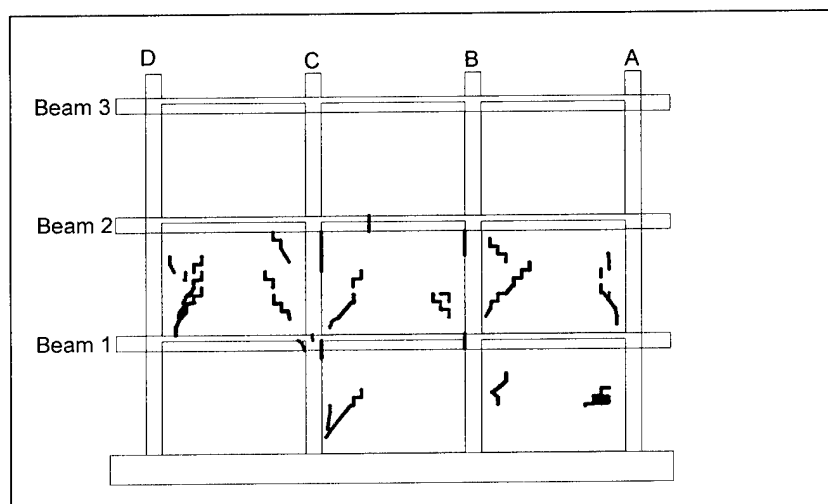
Figure 5.4. Cracks appearing during cycles 29 through 31.

Cycle 29 was the last cycle for which LVDT data are available. During this cycle, every second-floor panel achieved 0.2 in. of diagonal displacement, the maximum reading available for the LVDTs. Average readings for the first and third floor were approximately one half and one tenth, respectively, of the second floor value, as reflected by the relative amount of cracking on each floor at this time. Floor three had yet to crack and the first floor sustained minimal damage, with the exception of a spalled CMU block in panel 1A, depicted in Figure 5.4. Drift ratio data again corresponded to the damage: the first and third floors had drifted 0.338% and 0.136%, respectively, while the second floor drifted 0.56%. Note how most of the damage through cycle 31 was located on the outside perimeters of the damaged panels. At this point, no evidence of bed joint sliding or crushing of the toe was observed, and the center region was acting as a 'survival zone.'

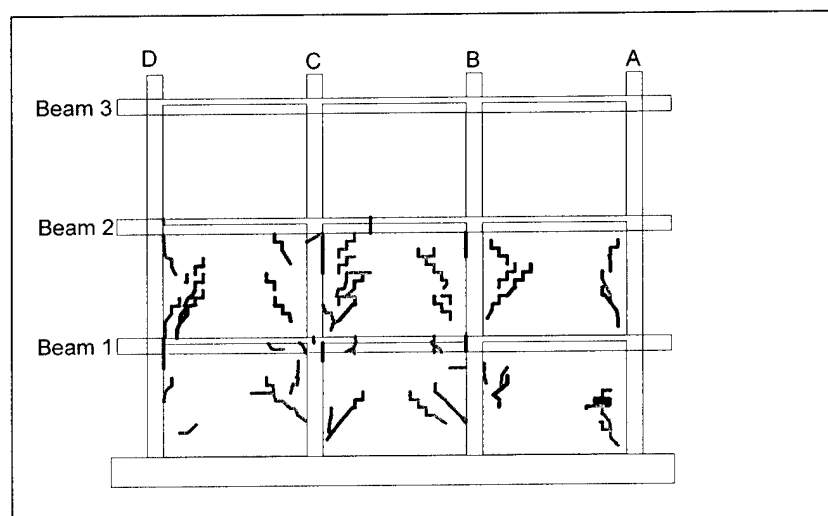
Figure 5.5. Cracks appearing during cycles 32 through 34.

The next major peak, cycle 32, cracked all the panels on the first floor and continued to damage the second floor, as depicted in Figure 5.5. The increased stair-stepping and CMUs cracking correlated to drift ratio values that were almost double those measured during cycle 29. Despite the second story drifting more than 1% during the positive stroke of cycle 32, there was no loss of strength to the frame, and in fact the load capacity increased slightly compared to cycle 29.

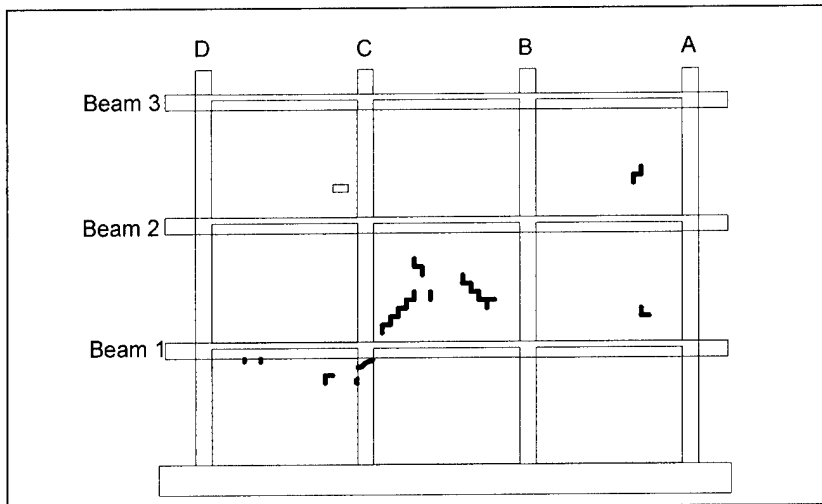
Figure 6.5. First cracks, cycles 21 through 24.

The first cracks appeared during the positive stroke of cycle 21, at a base shear of 16.63 kips. Cracks occurred on all three levels, but most of them were diagonal cracks forming in panel 2B, as shown in Figure 6.5. A number of the diagonal cracks were a combination of stair-stepping cracks through the mortar and cracked CMUs orientated at approximately 45 degrees. Throughout the rest of the test, the second floor continued to crack the most, with the highest crack propagation in the bottom six panels.

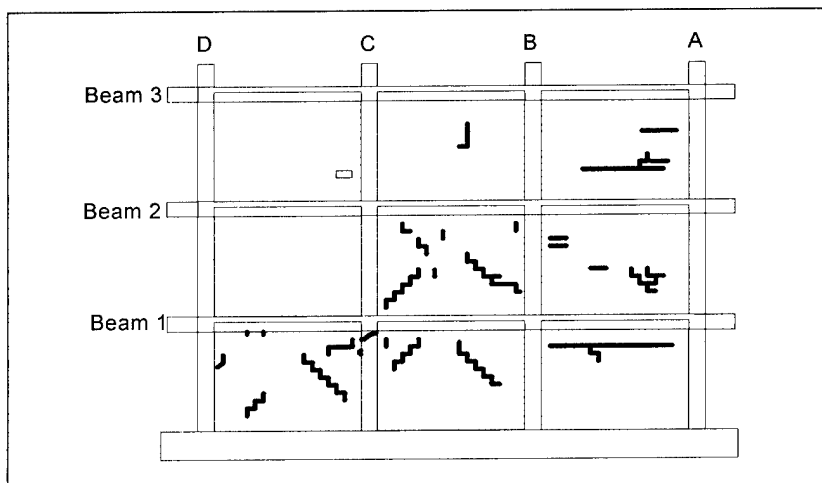
Figure 6.6. Cracks appearing during cycles 25 through 28.

As the test progressed from cycle 25 through 28, cracking occurred in all panels except 3C and 2C. Most cracks in the lower panels were stair-stepped, either continuations of old cracks or new formations. They were typically found in the corners of the panels moving toward the center, visually indicating strut action, as shown in Figure 6.6. During these cycles, the first appearance of bed joint cracking was seen in all three levels, mostly limited to bay A.

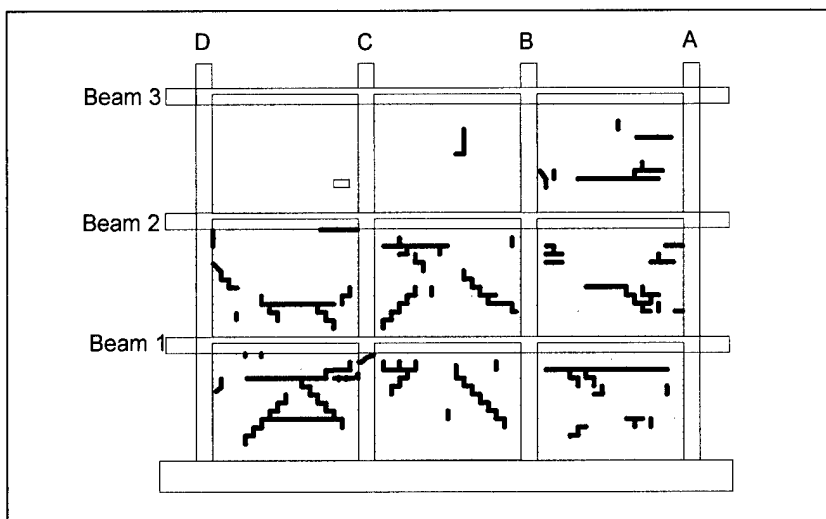
Figure 6.7. Cracks appearing during cycles 29 through 31.

During the positive stroke of cycle 29, LVDT readings in Panel 2B reached 0.185 in., a maximum value for this cycle. Although first floor LVDT readings were lower than those of the second floor, peaking at 0.15 in. in Panel 1B, cracking damage was similar. Both floors exhibited further propagation of both stair-stepped cracks and bed-joint cracks. The third floor sustained very little damage during this cycle. The second floor had the highest drift ratio at 0.42%, while third floor had the next-highest at 0.34%. Note how, as shown in Figure 6.7, most of the damage through cycle 31 was located on the outside perimeters of the damaged panels. At this point, crushing of the toe of the masonry panels had not been observed, and the center region of each panel was acting as a 'survival zone.'

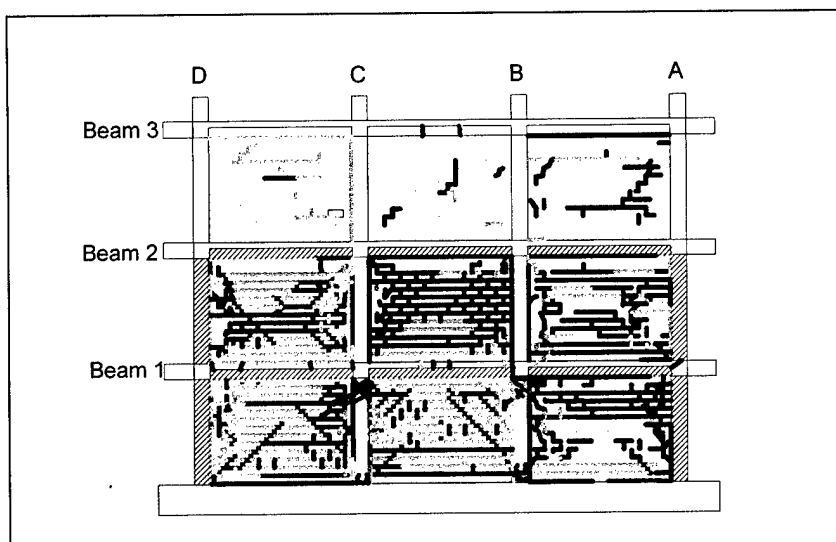
Figure 6.13. Cracks found after test of first story.

During the final three cycles, for the same reasons described in the previous paragraph, the second floor actuator was disengaged. This resulted in a lateral load being applied to the first floor only. Figure 6.13 illustrates the damage induced by these final cycles. A first floor load of 26.10 kips led to a maximum displacement exceeding 2.6 in., which corresponded to a drift ratio of almost 4.4%. Noticeable separation between the masonry and the overlaying beam occurred in the first floor. In addition, further damage to both the top and bottom of columns 1B and 1C was

observed, resulting in failure of both interior columns. By the conclusion of the test, the model had sustained extensive damage, nearly depleting its residual strength and stiffness.

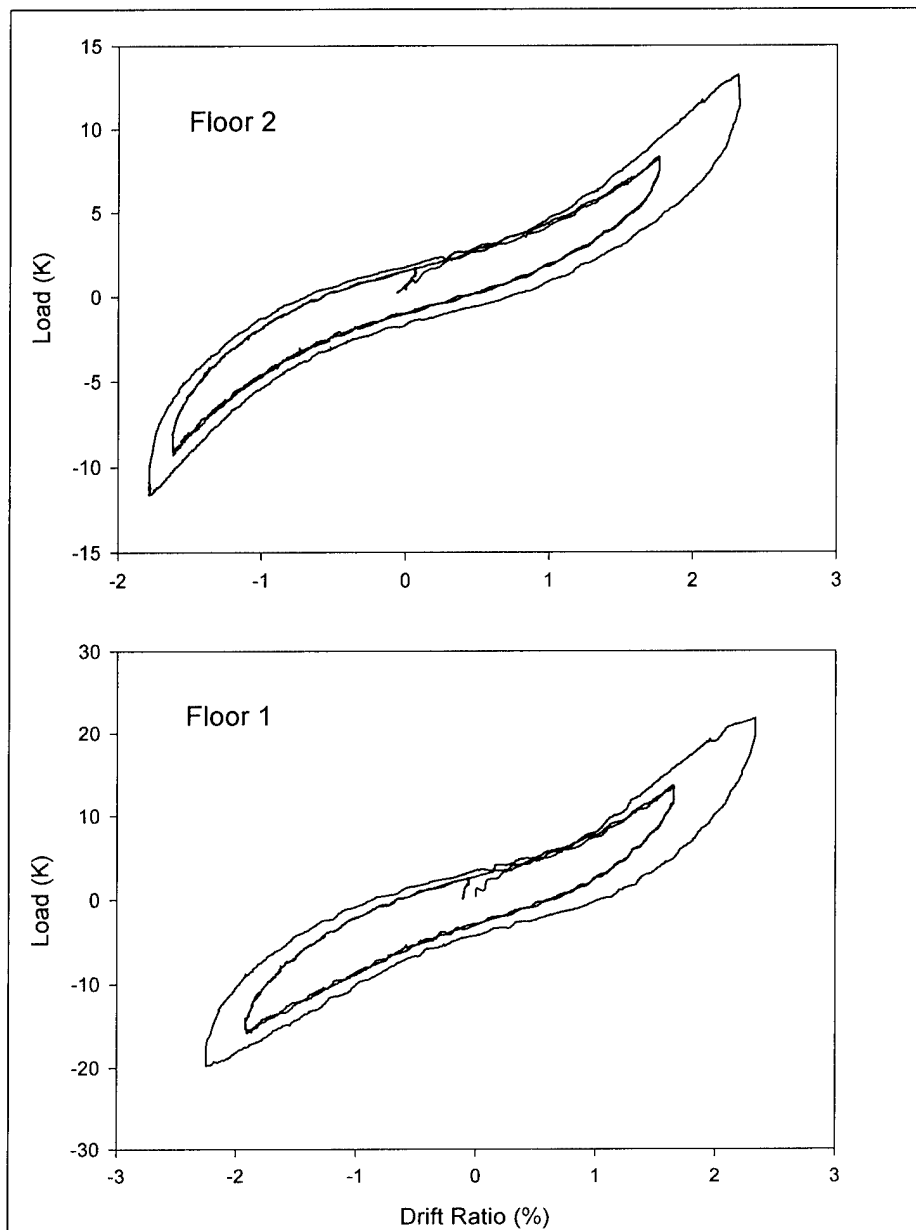
As explained previously, additional lateral load testing of Model 2 was conducted after completion of the 40-cycle modified CUREE loading protocol. The third floor actuator was disengaged in order to test the lower two levels at higher drifts, unconstrained by the displacement limits imposed on them by the third floor actuator. Keeping the ratio of force between the first and second levels constant at the same value as before, Model 2 was subjected to three additional cycles. The first cycle subjected the second floor to an absolute displacement of 3 in. The following two cycles were trailing cycles of smaller magnitude, in accordance with the modified CUREE loading protocol described previously. Figure 6.17 illustrates the hysteretic behavior of the first and second floors under these large demands. At this point, the rehabilitated model had lost much of its stiffness. The model can only resist considerable load at large drifts. When the lateral drift exceeded 2%, the rehabilitated model retained much of its residual strength by resisting a base shear of approximately 20 kips. The hysteresis curves of the second floor are especially pinched during these cycles signifying low energy dissipation.

Figure 6.17. Hysteretic behavior of the first and second floors at large drifts.

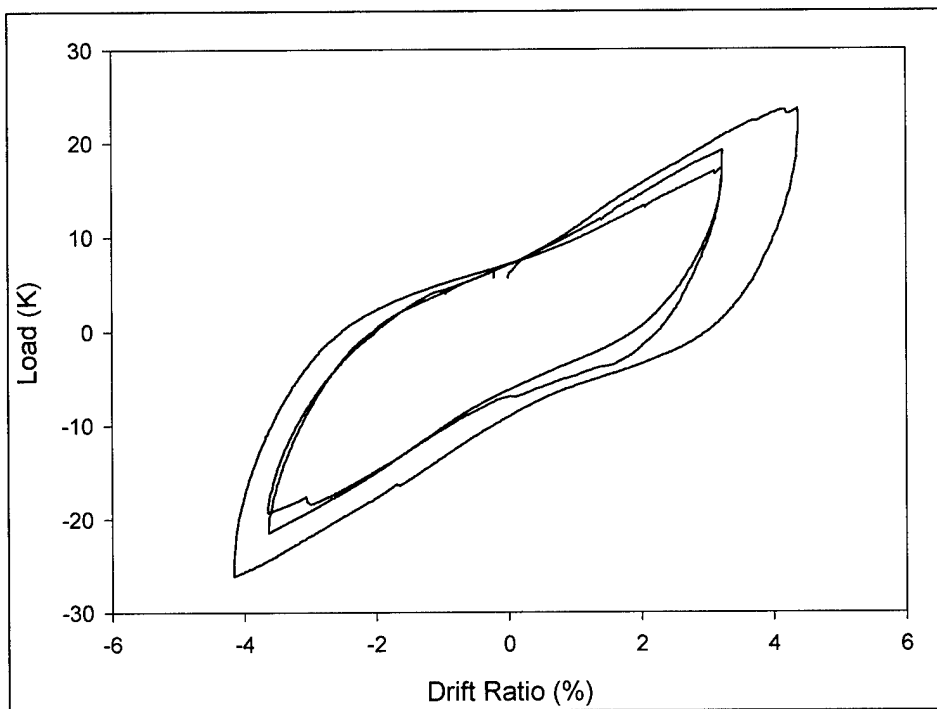
A similar procedure was followed in order to maximize demand on the first floor. The load/deformation behavior of the lower level during these three cycles is shown in Figure 6.18. During these cycles, a maximum drift ratio of approximately 4% was achieved along with a corresponding base shear of about 25 kips. Note that the hysteresis loops were fairly open for these three cycles, indicating considerable inelastic behavior. Significant damage to both the frame and the infill occurred during this time. After completing these three cycles, permanent inelastic deformation was evident in the first floor. Photographs showing the final damage to panels 1C and 1B (the most damaged regions in the model) are located in Figure 6.19 and Figure 6.20, respectively.

Figure 6.18. Hysteretic behavior of the first floor at large drifts.

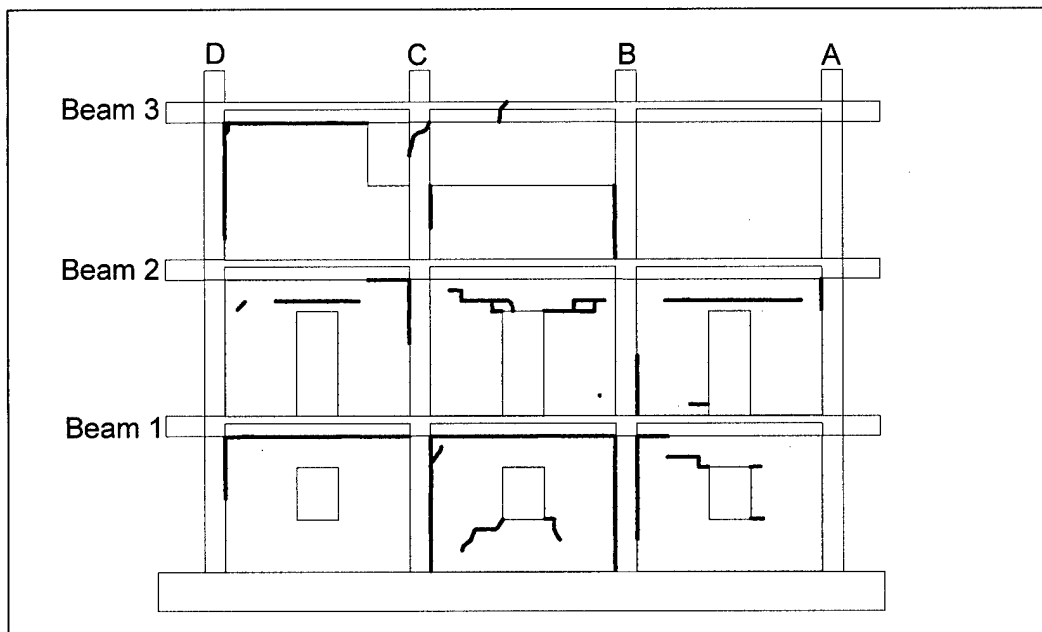
As the testing continued through cycle 29, the damage propagated in a similar manner: more masonry separated from the concrete frame and more cracks formed and grew in the mortar. The cracks were typically found near the corners of the openings, where the stress concentrations were large. Figure 7.3 shows the first cracks forming in the concrete frame, and these appear to be shear cracks. These

cracks appeared in concrete contiguous to bays 3B and 3C at points where there was no masonry to help support the concrete.

Figure 7.3. Cracks appearing during cycles 29 through 31.

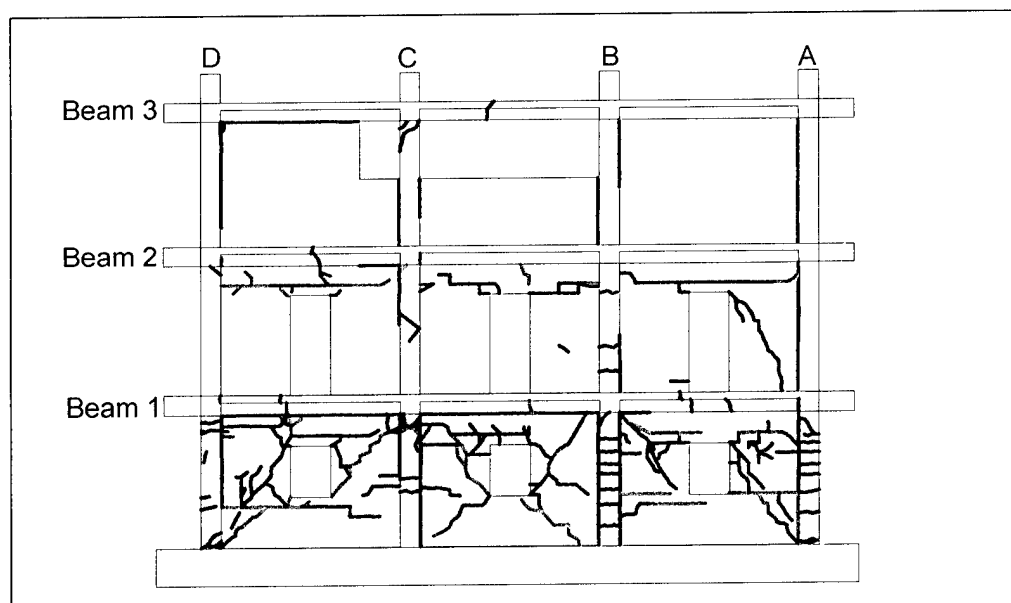
Figure 7.5 shows the cracks up through cycles 35-37. Here the first floor sustained heavy cracking. Multiple new cracks were formed, starting at the corners of the openings and traveling through the mortar and the bricks. The columns of the first floor sustained heavy cracking as well. This is due to the high levels of shear stress and strain that the first floor exhibited, which formed the horizontal cracks in the columns and mortar. The strain levels were higher than what the LVDTs could record on the first floor, while the second floor strain was around 0.4%. Also, the new LVDTs (LI1bc and LI1bb) recorded their maximum values during this group of cycles, indicating significant strain on the first floor walls near the windows.

Figure 7.5. Cracks appearing during cycles 35 through 37.

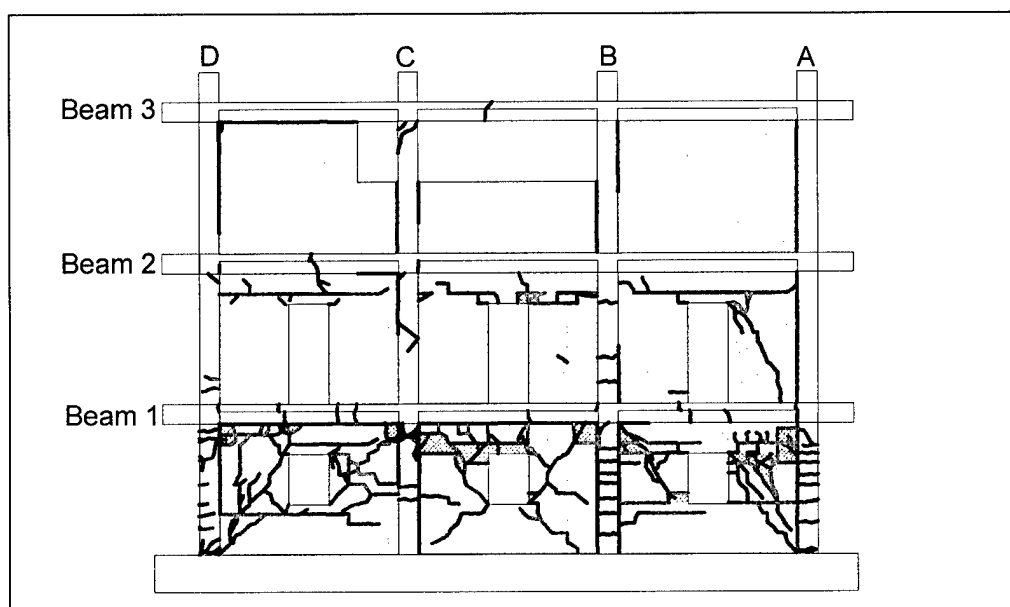
The first floor panels continued to crack during cycles 38 – 40, as shown in Figure 7.6. While the strain on the first floor was still greater than what the LVDTs could record, it was not as severe as before and there was less cracking. The second floor also had new cracking because of the high levels of stress (around 0.39%). Several of the new cracks caused sections of the panel to fall out, and the masonry was loose to the touch in many of the panels. The load capacity continued to drop with the increased deflections. At peak displacement of 2.76 in., the load carried by the top floor was only 19.3 kips — much less than the maximum carried load of 32.2 kips. Although the frame was still in its original shape, the damage done to the structure as a composite was severe: the masonry had lost most of its cohesiveness and the mortar was cracked. Only the third floor panels remained intact, although they had partially detached from the concrete frame in many places.

Figure 7.6. Cracks appearing during cycles 38 through 40.

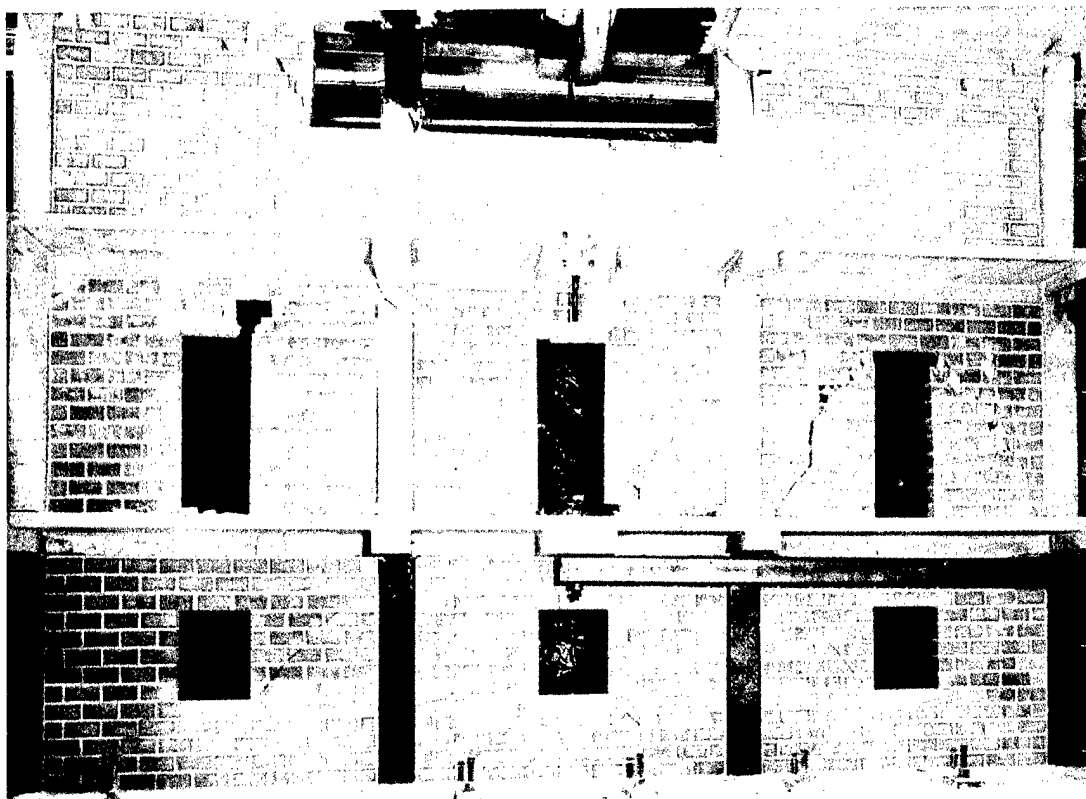
Figure 8.1. Rehabilitation of whole structure.

Before application of the CFRP, the flexural and shear cracks in the beams were repaired using the techniques described in Chapter 6, Section 6.2, which comply with applicable portions of ASTM C-881. Figure 8.1 and Figure 8.2 show photographs of portions of the rehabilitated frame. The CFRP is the black material covering the beams, and the J-51 sealant is the gray material covering the beam cracks.

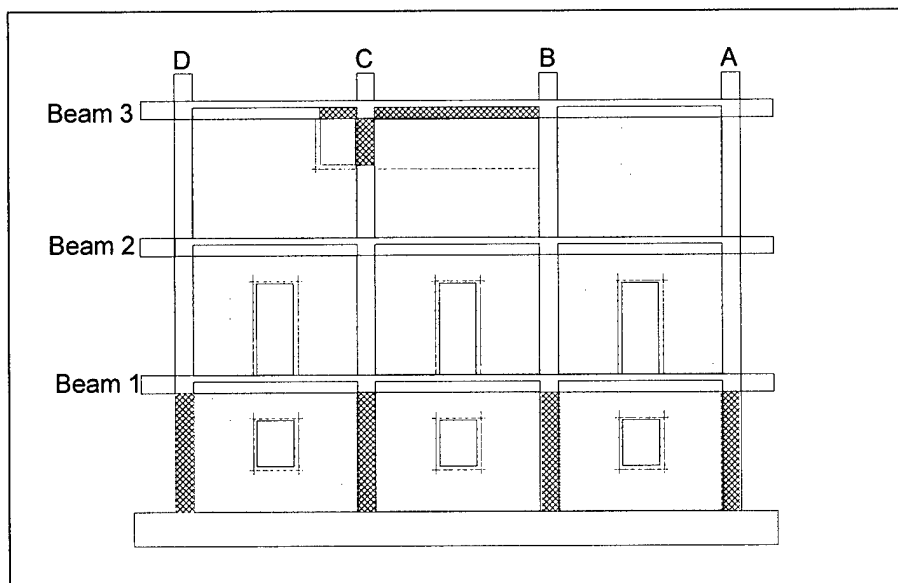
Figure 8.3. Location of frame elements where CFRP was applied.

CFRP with a fiber orientation of $+45/-45$ degrees was used to strengthen the R/C frame according to ACI 440-00, as illustrated in Figure 8.3. The first floor columns were completely wrapped, along with the top half of Column C on the third floor. Also, the stem of Beam 3, a T-beam, was wrapped adjacent to the openings in masonry panels 3B and 3C.

The first floor and the third floor columns were completely wrapped, while beam 3 was U-wrapped around the three sides of its stem. Calculations were not performed to determine the rehabilitated shear, bending, or axial strengths, but it is reasonable to assume that these values for Model 4 should exceed the undamaged capacities of Model 3 (from which Model 4 was reconstructed). After the frame itself was rehabilitated with CFRP, the first floor CMU infill panel was replaced.

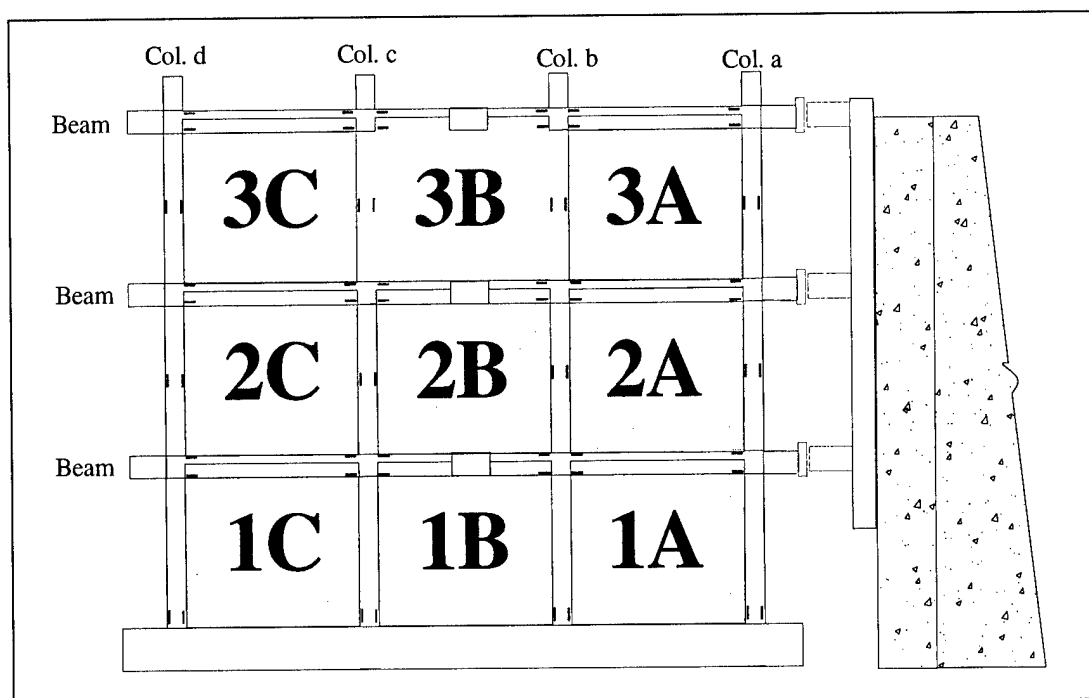
Figure 8.5. Identification scheme for Model 4.

Model 4 is discussed in terms of the element identification scheme illustrated previously and repeated in Figure 8.5. As in Tests 1 – 3, the model was loaded using the previously described modified CUREE protocol. The first cracks appeared during cycle 21, with a maximum load of 9.2 kips acting on the third floor. Figure 8.6 shows the cracks appearing at the joints between column B and beam 2, and between column C and beam 2. Throughout the rest of the test, the second floor continued to form a majority of the cracks.

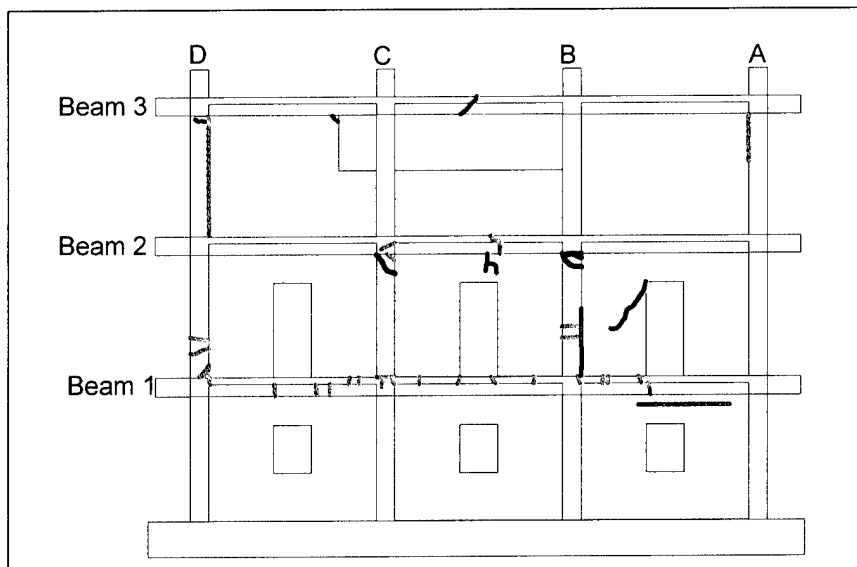
Figure 8.7. Cracks appearing during cycles 25 through 28.

Figure 8.7 shows the cracks that formed during cycles 25 through 28. Panels 1A, 2A, 2B, 3C all cracked, and most of these cracks traveled along the mortar joints. However, in panel 2A the crack propagated through bricks as well as mortar. Also the lower left side of panel 2A disconnected from the concrete frame. The concrete frame also formed two new cracks — one in Beam 3 above panel 3B, contiguous to the opening, and one at the top of column D.

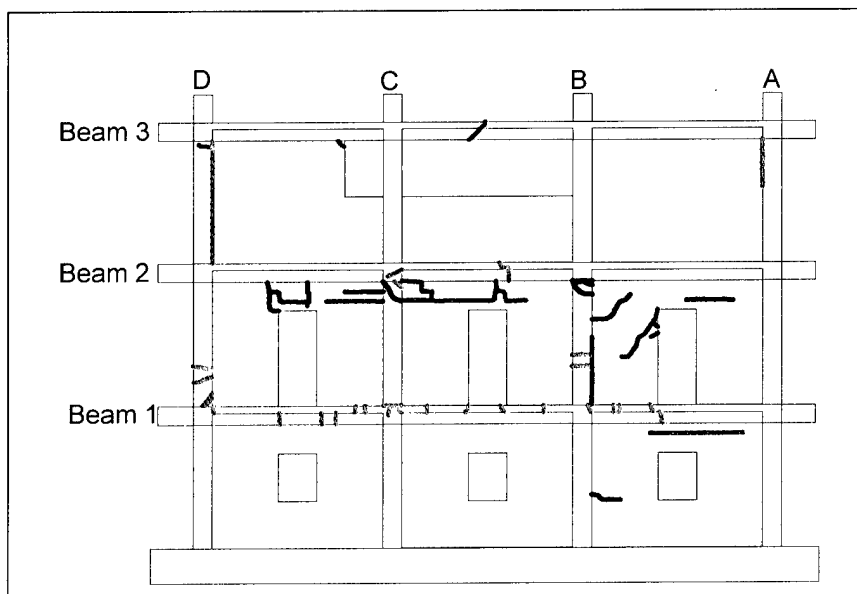
Figure 8.8. Cracks appearing during cycles 29 through 31.

The cracks that appeared during cycles 29 through 31 are shown in Figure 8.8. Here the second floor received most of the new cracks, with the only other crack appearing in panel 1A. Two of the cracks in the second floor were continuations of previous cracks, but there were also new cracks. Panel 2C cracked for the first time above the doorway, while in panel 2B all the cracks that occurred previously joined together.

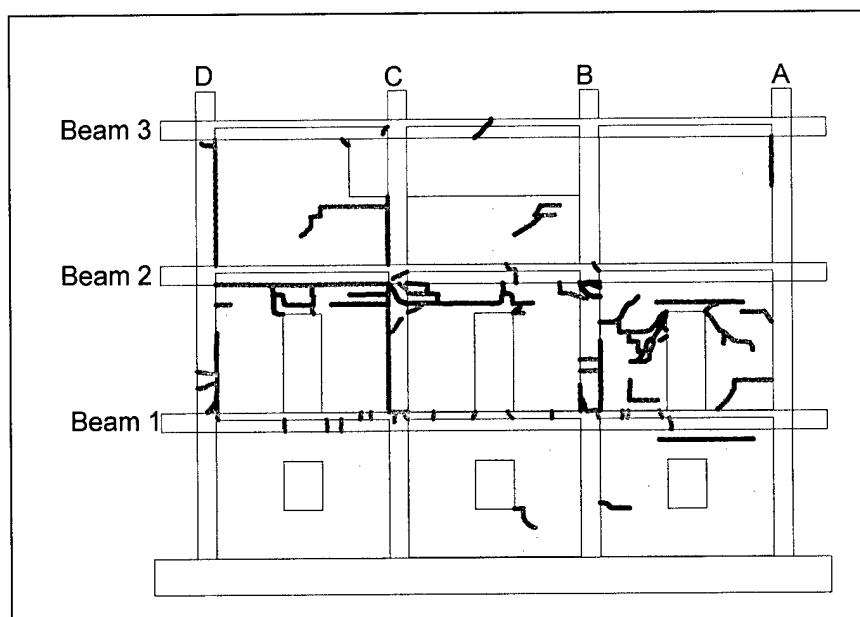
Figure 8.9. Cracks appearing during cycles 32 through 34.

Figure 8.9 shows the crack propagation during cycles 32 through 34. During this test the second floor had an increase in the number of cracks. All three panels developed new cracks, with most of these occurring in panel 2A around the corners of the doorway, where stress concentrations were very high. Most of the cracks in panel 2C occurred along the border between the panel and the concrete frame. Two panels, 3B and 1B, cracked for the first time, with the cracks traveling through both mortar and brick. Also the concrete frame developed a number of new cracks, most of them near joints.

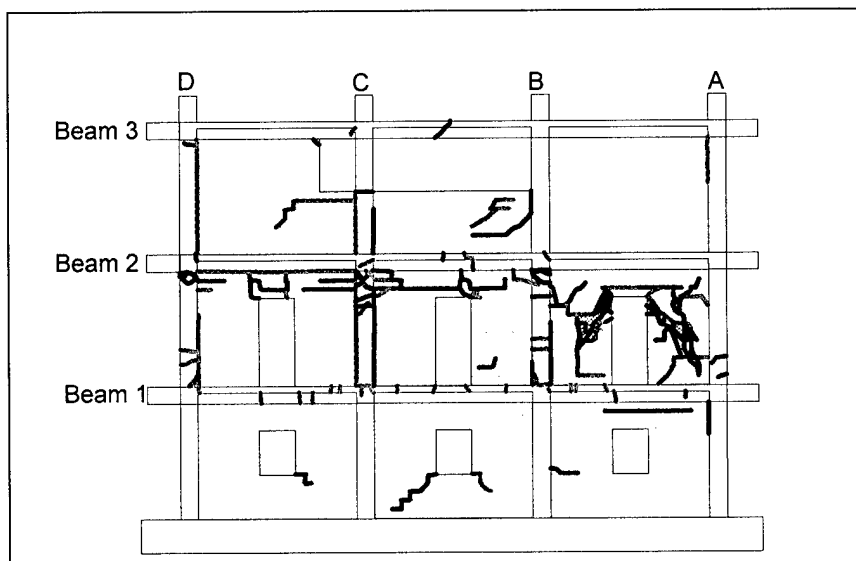
Figure 8.10. Cracks appearing during cycles 35 through 37.

Cycles 35 through 37 (Figure 8.10) show more new cracks, with many of them occurring in panel 2A. Here the cracks occurred in the same places as previously; only the density of cracks increased. Also, the first floor had an increase in the number of cracks, with some panel separation happening in panel 1A, a new stair-step crack happening at the window corner in panel 1B, and panel 1C having its first crack at the corner of a window. Panel 3B showed some separation from the frame on both sides, along with a new crack at the right side. Also, the joints at columns B and C and beam 2 had a large number of cracks occur.

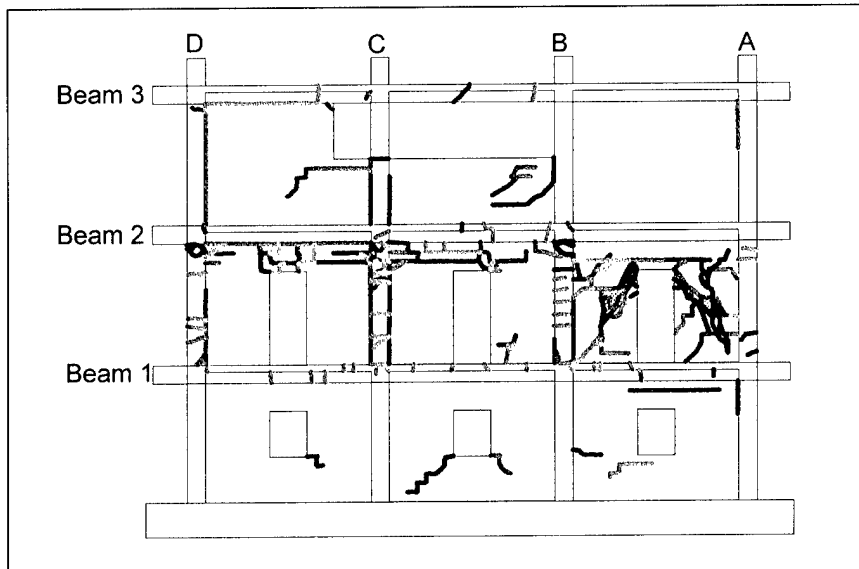
Figure 8.11. Cracks appearing during cycles 38 through 40.

Figure 8.11 displays the cracks occurring during cycles 38 through 40. Most of the cracks were near the top of the panel, or they were continuations of previous cracks. Panel 1A developed a new crack. Most of the cracks that formed were in the columns along the second floor, with some in beams 2 and 3.

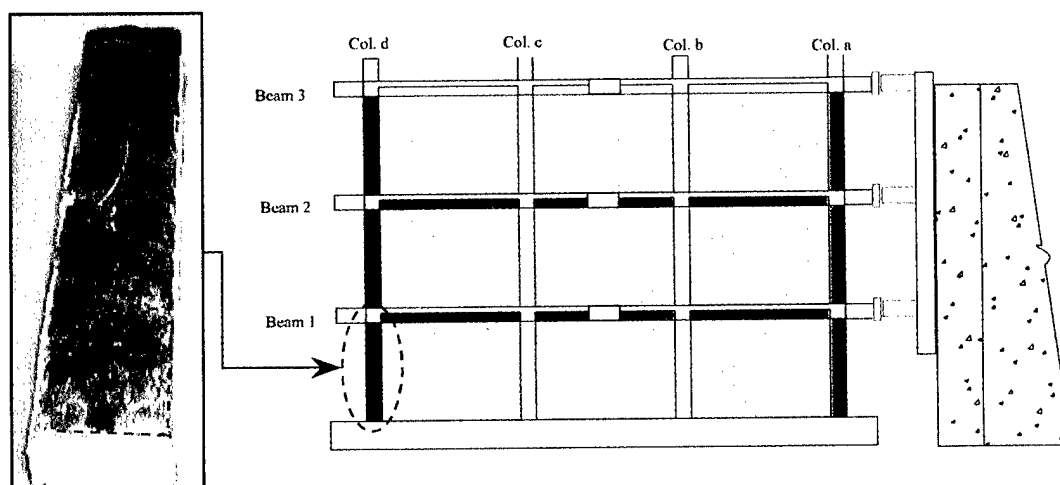
Figure A.9. FRP/concrete section of ERDC/CERL column from Model 2. The areas indicated on the column section were inspected with the guided wave AU system.

The loading process created cracking in some of the structural components, among them the column section shown in Figure A.9. In order to examine the condition of the bonding between the FRP and the concrete column, C-scan images of five different sections of the column were generated, as also indicated in Figure A.9. Figure A.10 shows a picture of the multi-sensor probe mounted on the scanning bridge while inspecting the FRP retrofitted column.

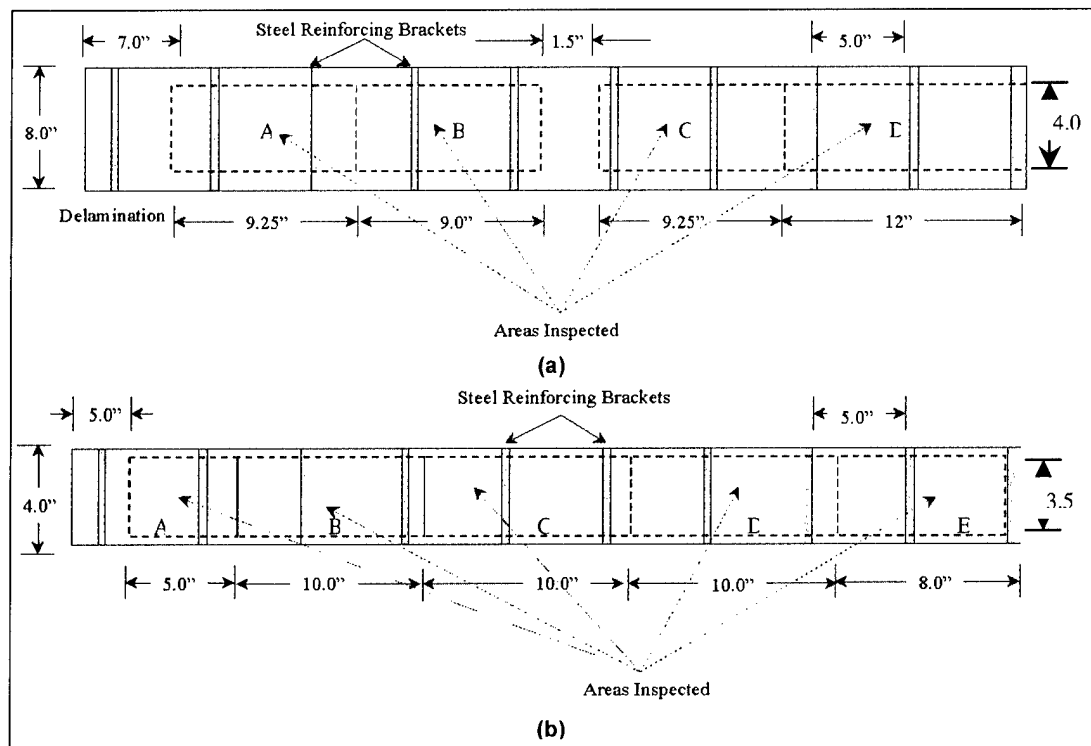
Four sections of side V of the column section were scanned. These sections were 9.25 in. (A), 9.0 in. (B), 9.25 in. (C), and 12 in. (D) long and 4 in. wide, as shown in Figure A.16(a). These sections were chosen because the FRP surface roughness and ripples were smaller than 0.0625". Ripples higher than 0.0625 in. made good coupling between the sensor probe and the FRP very difficult. Also, five sections were scanned on side W as shown in Figure A.16(b). The dimensions of these sections were 5.0 in. (A), 10.0 in. (B), 10.0 in. (C), 10.0 in. (D), and 8.0 in. (E) long and 3.5 in. wide.

Figure A.16. Dimensions and location of the areas inspected on the FRP-retrofitted column section: (a) side V and (b) side W.

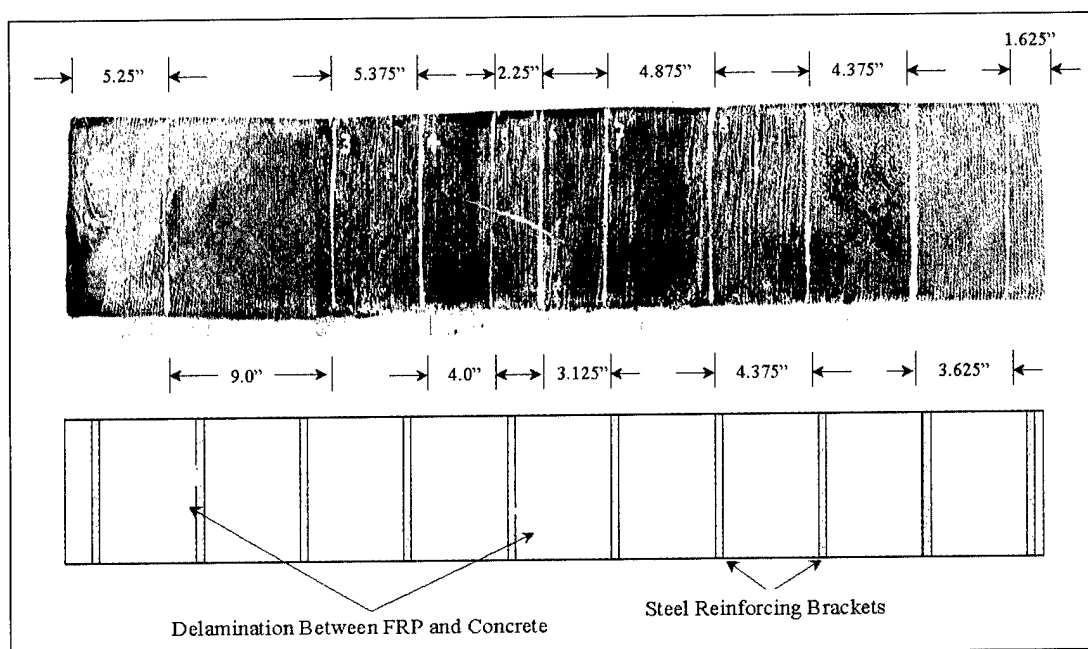
A total of ten cuts were made, eight of them in places where the C-scans of Figure A.18(b) show indications of the presence of reinforcing stirrups, and the remaining two in the middle of the locations where Figure A.18(b) showed evidence of delamination. As a result of this process, the column was cut into 11 pieces.

Figure A.21. Location of the cuts performed on the column section. The position of the cuts was determined according to the delaminations and stirrup positions on side V.
